Manhole Inspection Summary

Manhole # S67S__005MH

Location Address: **1613 Pumphry St.**

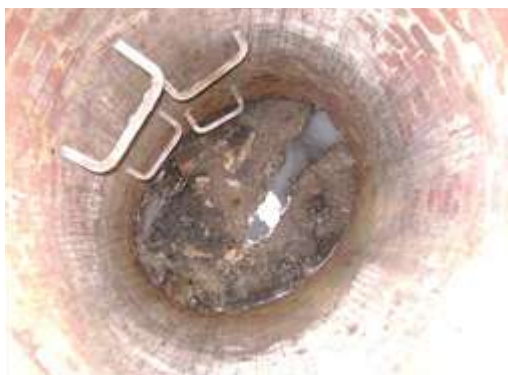
Defect 1

Comments **HEAVY DEBRIS IN CHANNEL.**

Condition: ☐ Sound ☐ Cracked ☐ Root Intrusion ☐ Deteriorated ☐ Leaks ☒ **Debris**

Lot of debris

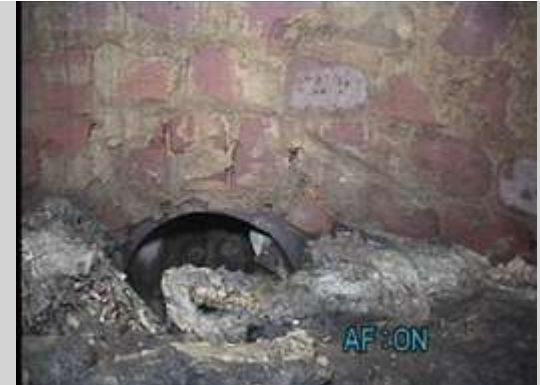
12 O'Clock Outflow

8 in. Circular Gravity Sewer
Pipe Out @ 12 O'Clock

Pipe Height: **8.4** (in.) Rod and Bar (Angled)
Pipe Material: **Clay** ☐ Pipe Lined
Invert Depth: **10.33** (ft.) Flow Characteristics: **Slow**
Deposits: ☐ None ☐ Mud ☐ Sludge ☒ **Debris** ☐ Grease
Silt Depth: **1** (in.) Deposits Extent: **Light**
Infiltration: **None** Pipe Seal Cond: **Sound**

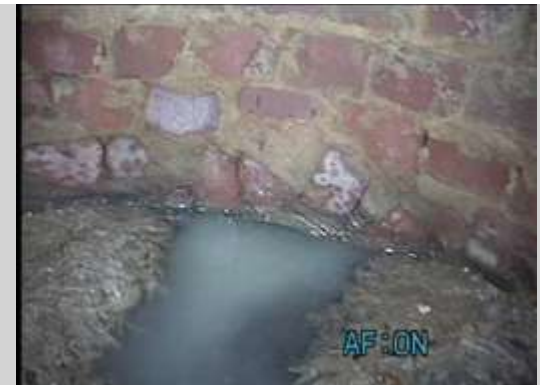
7 O'Clock Inflow

8 in. Circular Gravity Sewer
Pipe In @ 6 O'Clock

Pipe Height: **8.4** (in.) Rod and Bar (Angled)
Pipe Material: **Clay** ☐ Pipe Lined
Invert Depth: **10.25** (ft.) Flow Characteristics: **Slow**
Deposits: ☐ None ☐ Mud ☐ Sludge ☒ **Debris** ☐ Grease
Silt Depth: **2** (in.) Deposits Extent: **Medium**
Infiltration: **None** Pipe Seal Cond: **Sound**
